Dynamic Full Scale Tests of Median Barriers

May 1959

State of California
Department of Public Works
Division of Highways

59-04

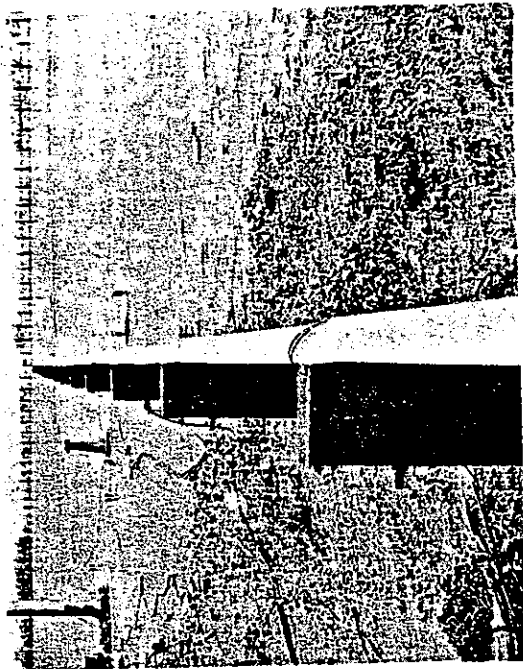
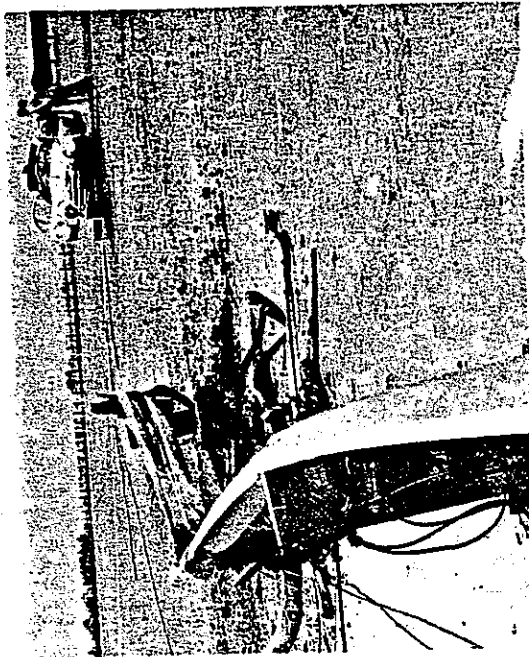
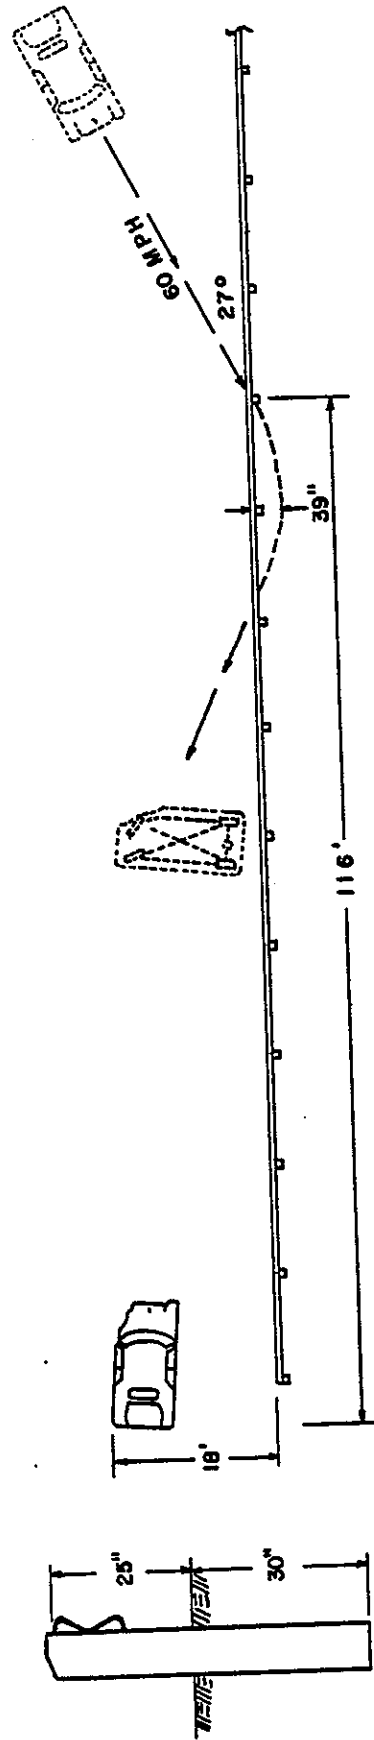
GUARDRAIL	W Section	DUMMY INJURY	Left shoulder & side injuries. Possible concussion.	TEST NO.	1
BRACKET	None	GUARDRAIL DAMAGE	3 Sections damaged beyond repair.	DATE	7-10-58
POST	8x8 D.F.	POST DAMAGE	2 Posts damaged beyond repair.	VEHICLE	Chev. 52 Sedan
POST SPACING	12'-6" O.C.	VEHICLE DAMAGE	12 Posts out of alignment.	SPEED	60 MPH
LENGTH OF INSTALLATION	212.5'	MAX. DYNAMIC DEFLECTION OF RAIL	48"	IMPACT ANGLE	27°
GROUND CONDITION	Dry			VEHICLE WEIGHT ...	3980
				(W/DUMMY & INSTRUMENTATION)

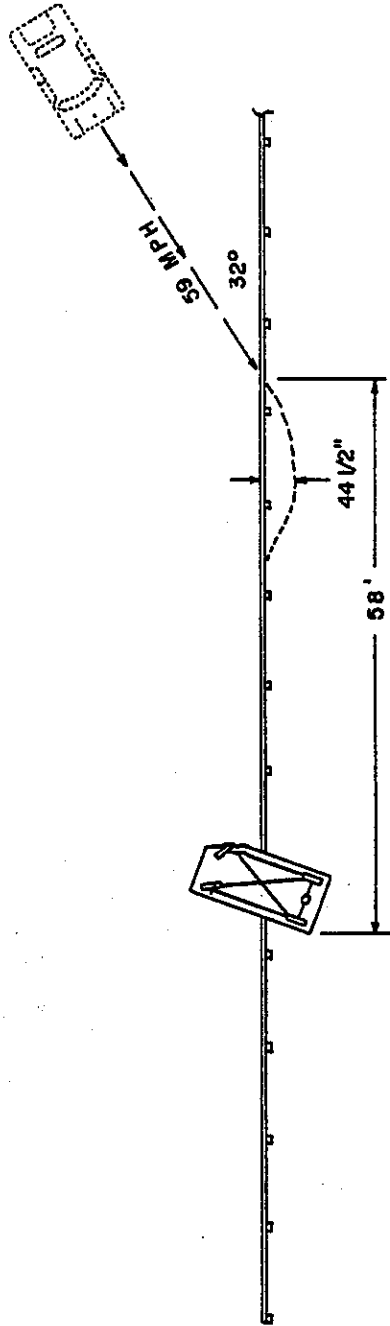
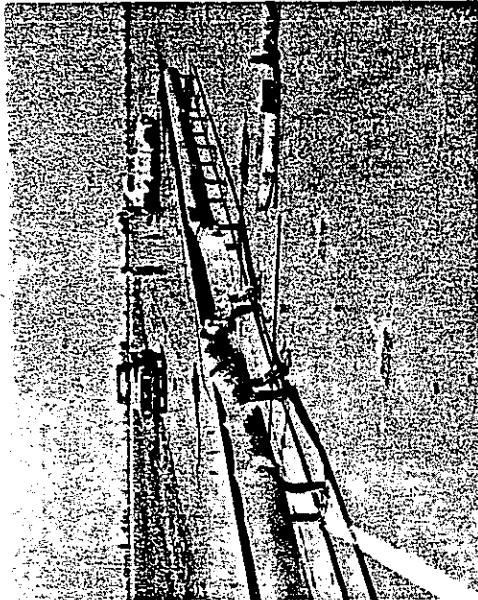
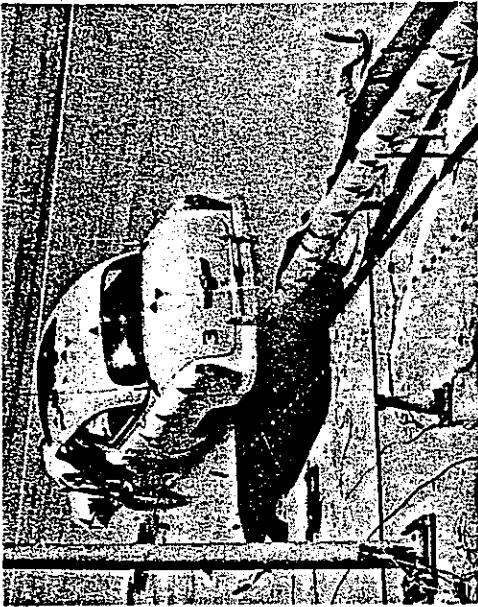
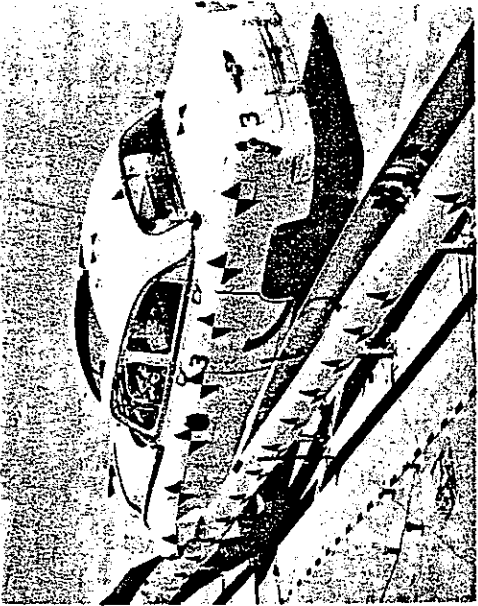
TEST NO.2
DATE7-23-58
VEHICLEChev. 50 Sedan
SPEED 59 MPH
IMPACT ANGLE 32 °
VEHICLE WEIGHT....3980
(W/DUMMY & INSTRUMENTATION)

DUMMY INJURY Severe head, neck, chest, & internal injuries.
GUARDRAIL DAMAGE 4 Sections damaged beyond repair.
POST DAMAGE 5 Posts damaged beyond repair.
VEHICLE DAMAGE 10 Posts out of alignment.
MA X. DYNAMIC DEFLECTION OF RAIL... 56 1/2"

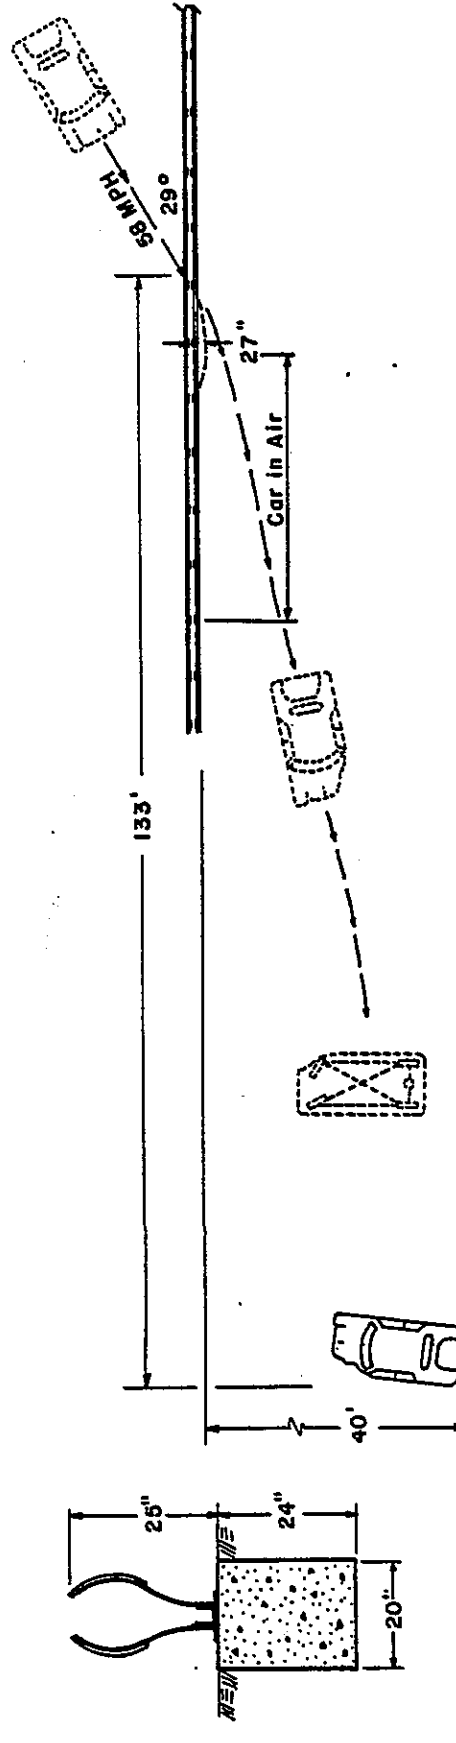
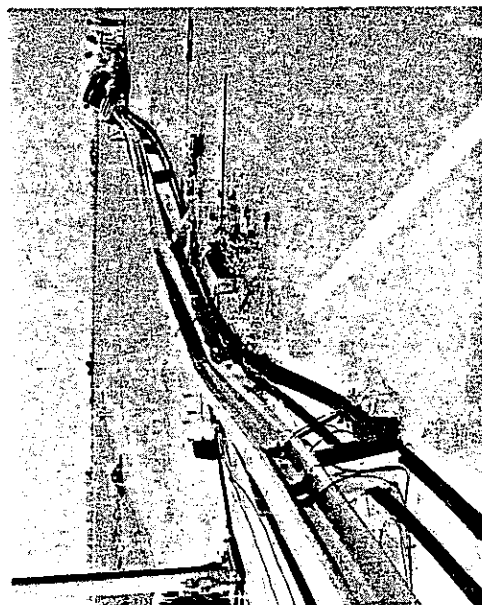
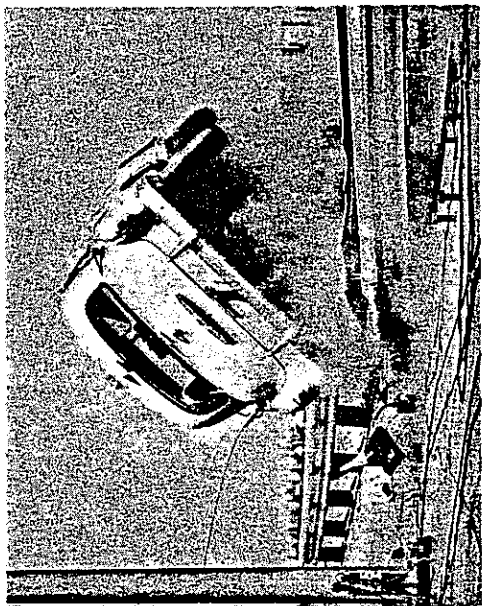
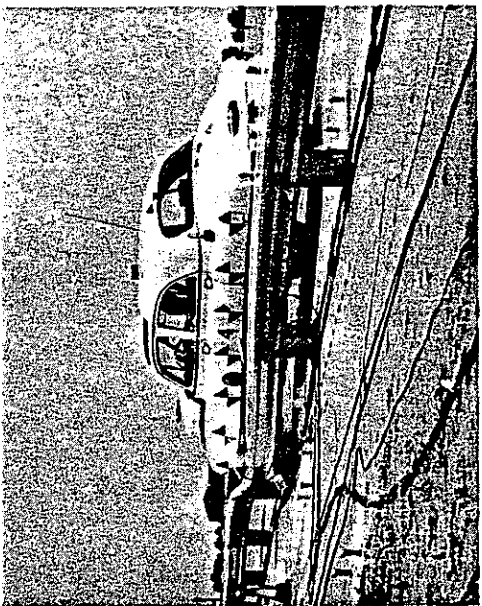
DATE8-6-58
VEHICLEChev. 53 Sedan
SPEED58 MPH
IMPACT ANGLE29°
VEHICLE WEIGHT... 3980
(W/DUMMY & INSTRUMENTATION)

DUMMY INJURYLeft shoulder & side injuries. Possible concussion.TEST NO.3
GUARDRAIL DAMAGE4 Sections damaged beyond repair .
Inside rail failed.
POST DAMAGE6 Brackets damaged beyond repair.
VEHICLE DAMAGETotal loss
MAX. DYNAMIC DEFLECTION OF RAIL...27" Before failure.

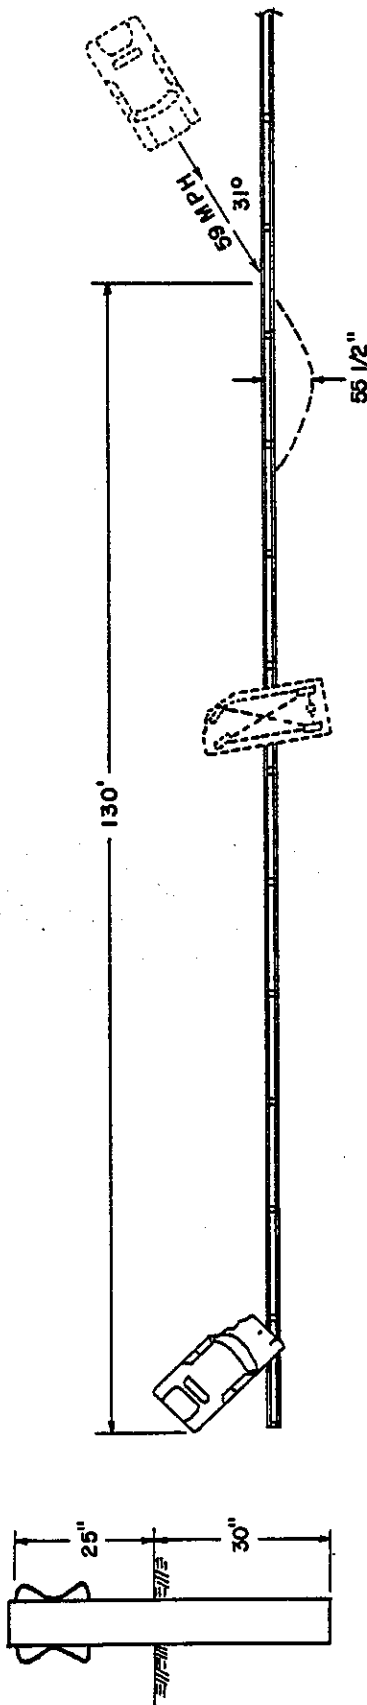
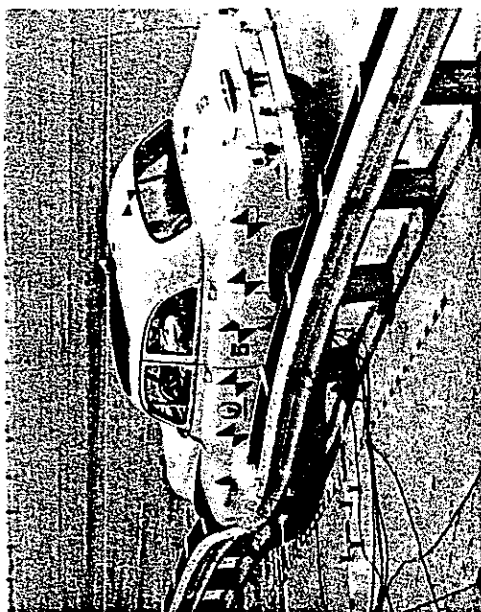
TEST NO. 4
 DATE 8-20-58
 VEHICLE Chev. 51 Sedan
 SPEED 59 MPH
 IMPACT ANGLE 31°
 VEHICLE WEIGHT... 3980
 (W/DUMMY & INSTRUMENTATION)

DUMMY INJURY Severe neck, head & left shoulder injuries.
 GUARDRAIL DAMAGE 3 Sections damaged beyond repair.
 POST DAMAGE 1 Post damaged beyond repair.
 VEHICLE DAMAGE 7 Posts out of alignment.
 MAX. DYNAMIC DEFLECTION OF RAIL... 60 "

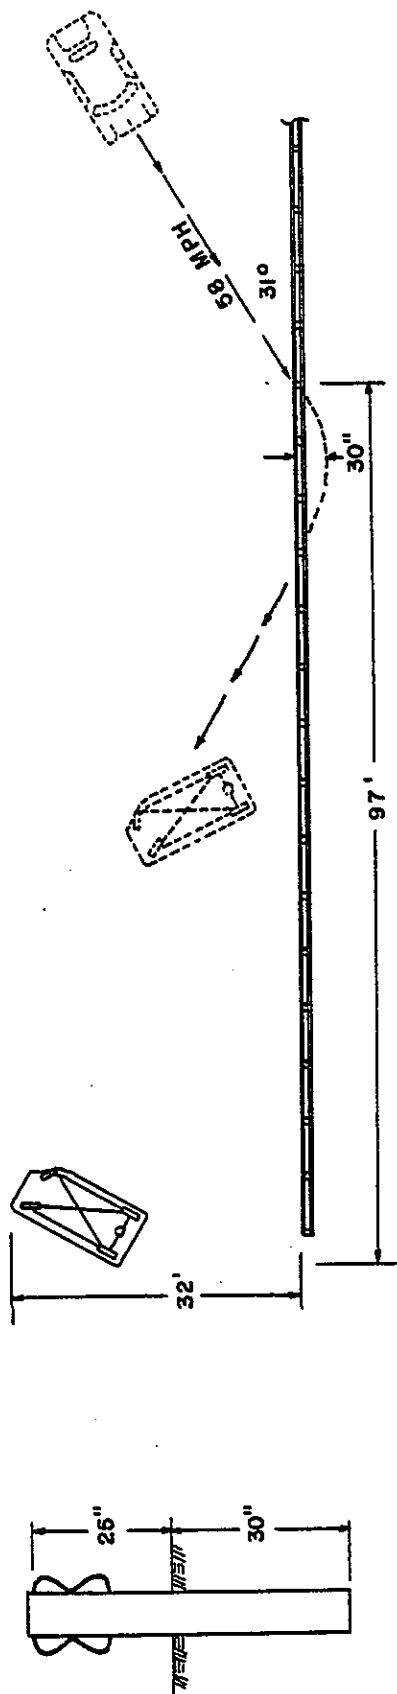
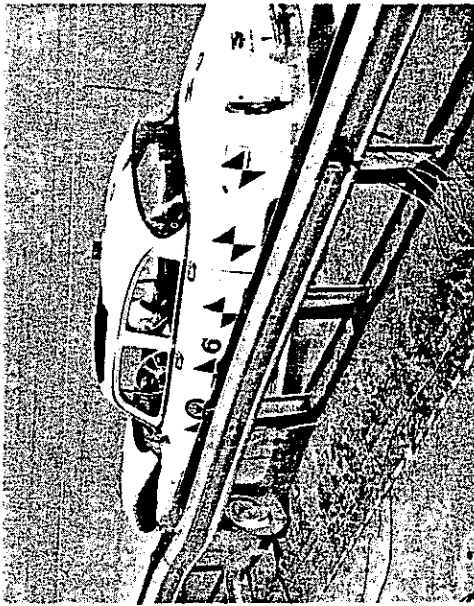
GUARDRAIL	W Section	DUMMY INJURY	Severe left shoulder & arm, head & neck injuries.	TEST NO.	5
BRAKET	None	GUARDRAIL DAMAGE	2 Sections damaged beyond repair.	DATE	8-27-58
POST	8x8 D.F.	POST DAMAGE	3 Posts damaged beyond repair.	VEHICLE	Chev. 51 Sedan
POST SPACING	6'-3" O.C.	VEHICLE DAMAGE	5 Posts out of alignment.	SPEED	58 MPH
LENGTH OF INSTALLATION...	200'		Total loss.	IMPACT ANGLE	31°
GROUND CONDITION	Dry			VEHICLE WEIGHT	3980
				(W/DUMMY & INSTRUMENTATION)	
				MAX. DYNAMIC DEFLECTION OF RAIL	40.5"

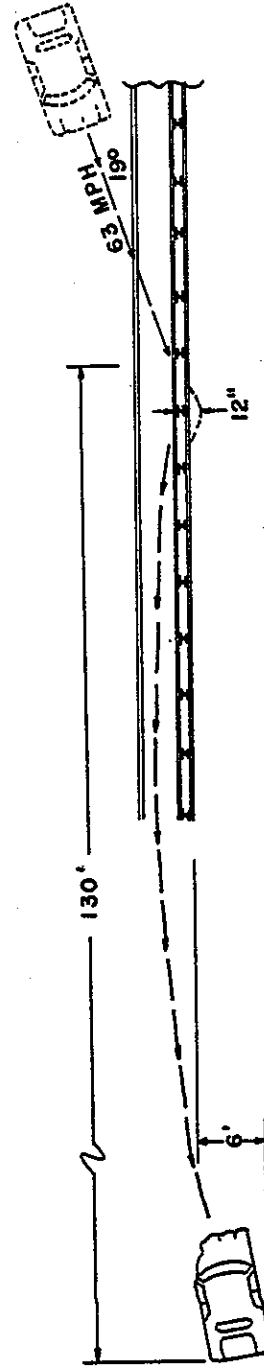
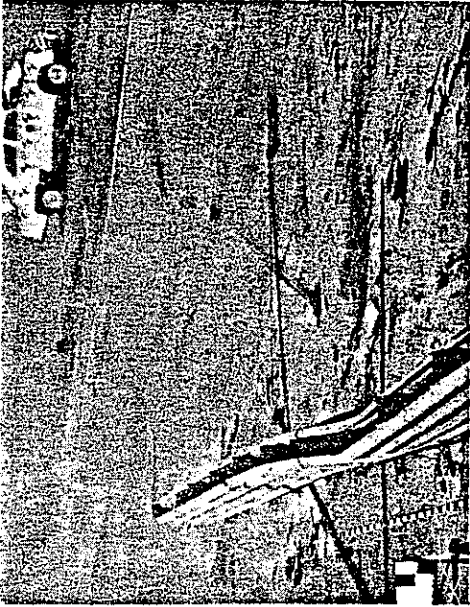
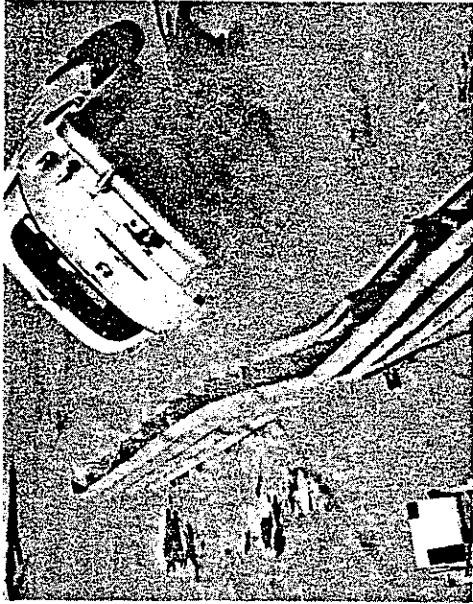
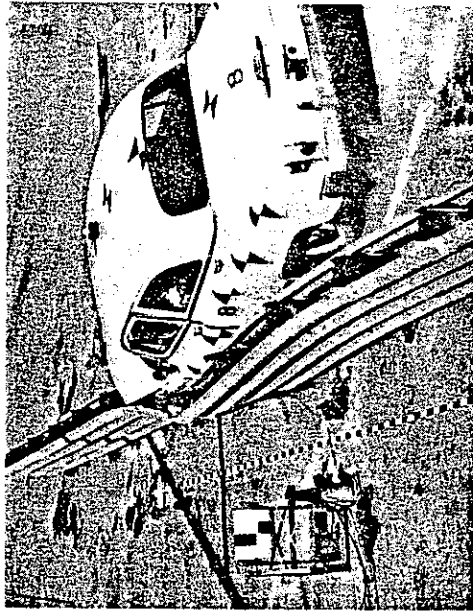
TEST NO.....7
DATE..... 9-18-58
VEHICLE..... Chev. 54 Sedan
SPEED..... 63 MPH
IMPACT ANGLE.....19°
VEHICLE WEIGHT....4050
(W/DUMMY & INSTRUMENTATION)

DUMMY INJURY..... Severe head, chest & internal injuries.
GUARDRAIL DAMAGE..... 2 Sections damaged beyond repair.
POST DAMAGE..... 2 Posts damaged beyond repair.
2 Posts out of alignment.
VEHICLE DAMAGE..... Total loss.
MAX. DYNAMIC DEFLECTION OF RAIL...19"

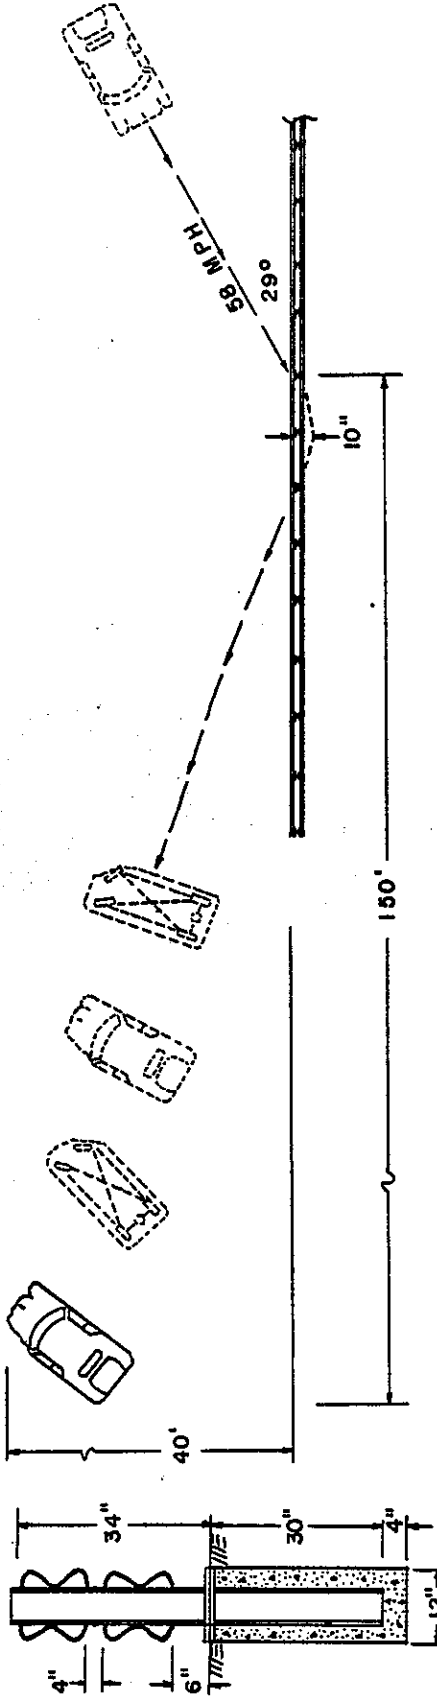
TEST NO 8
DATE 10-2-58
VEHICLE Chev. 52 Sedan
SPEED..... 58 M.P.H
IMPACT ANGLE..... 29°
VEHICLE WEIGHT... 4050
(W/DUMMY & INSTRUMENTATION)

DUMMY INJURY Severe head , shoulder & arm injuries.
GUARDRAIL DAMAGE Multiple lacerations & concussion.
POST DAMAGE 2 Sections damaged beyond repair.
VEHICLE DAMAGE All can be repaired.
MAX. DYNAMIC DEFLECTION OF RAIL... 15 "

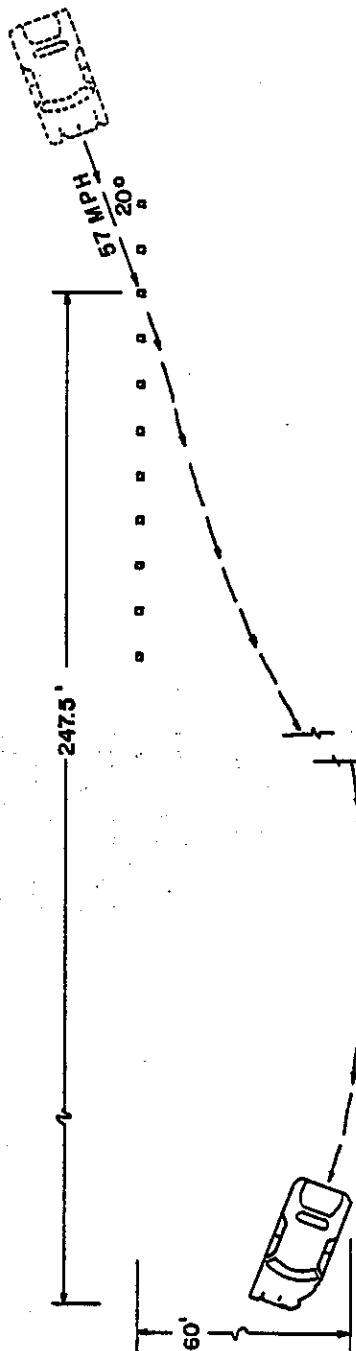
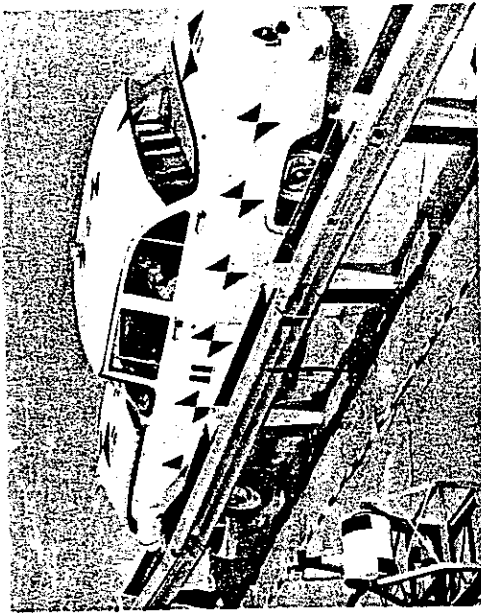
TEST NO. 10
 DATE 10-23-58
 VEHICLE Chev. 53 Sedan
 SPEED 57 MPH
 IMPACT ANGLE 20°
 VEHICLE WEIGHT... 3970
 (W/DUMMY & INSTRUMENTATION)

DUMMY INJURY Minor Bruises
 GUARDRAIL DAMAGE No rail.

POST DAMAGE 3 Posts demolished.
 1 Post out of alignment.

VEHICLE DAMAGE Est. \$ 500.
 MAX. DYNAMIC DEFLECTION OF RAIL... No rail.

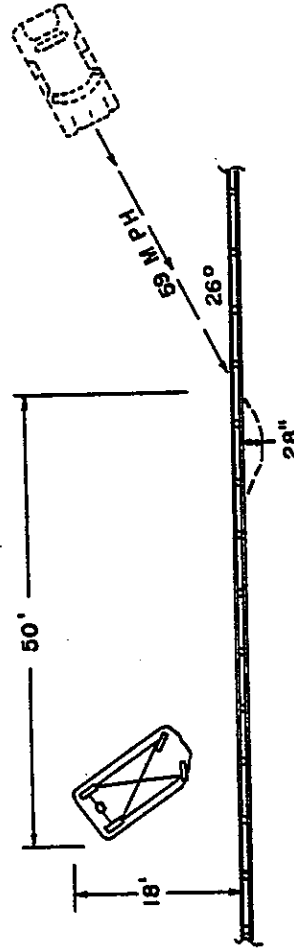
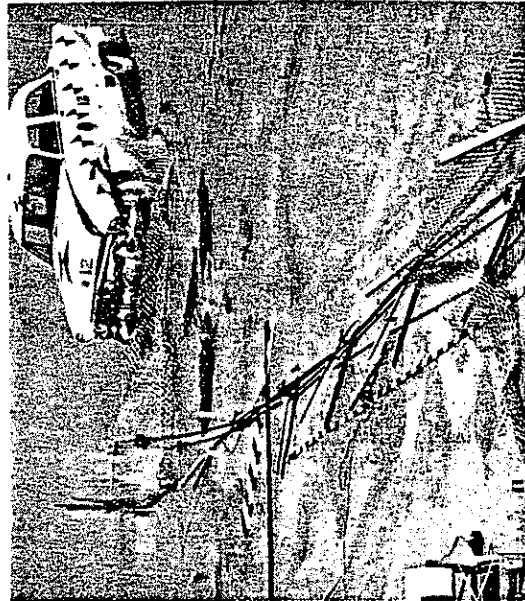
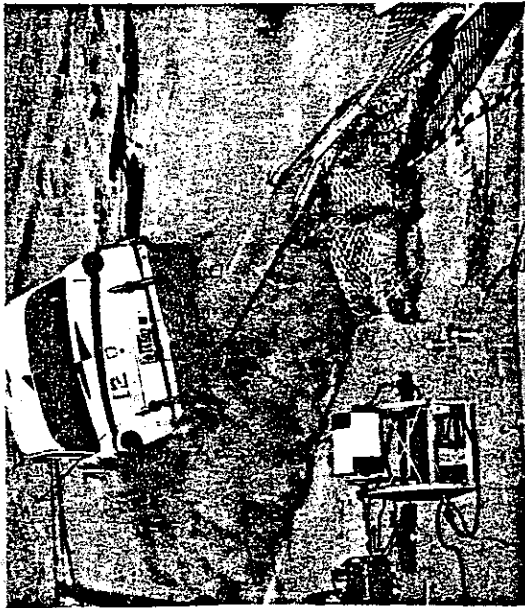
TEST NO. 11
 DATE 10-30-58
 VEHICLE Ford 55 Sedan
 SPEED 59 M.P.H.
 IMPACT ANGLE 26°
 VEHICLE WEIGHT... 4050
 (W/DUMMY & INSTRUMENTATION)

DUMMY INJURY Left shoulder & side, chest & internal injuries.
 GUARDRAIL DAMAGE 6 Sections damaged beyond repair.
 POST DAMAGE 3 Posts damaged beyond repair.
 VEHICLE DAMAGE 3 Posts out of alignment.
 MAX. DYNAMIC DEFLECTION OF RAIL... 40"

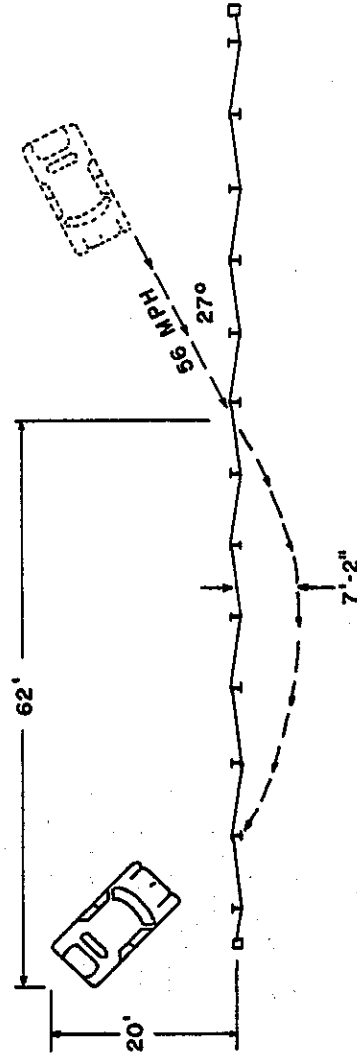
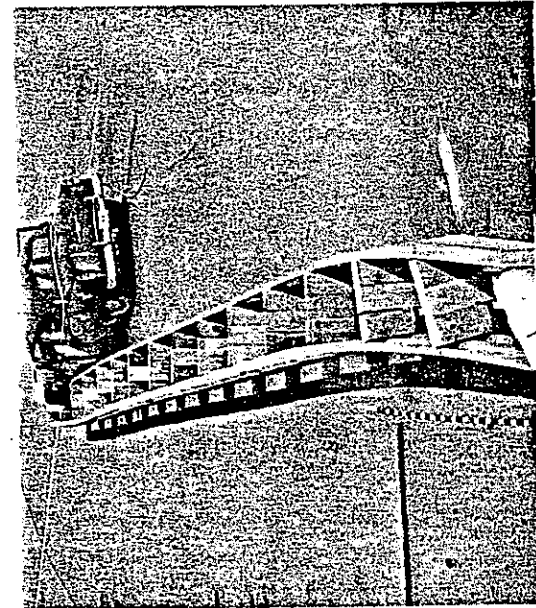
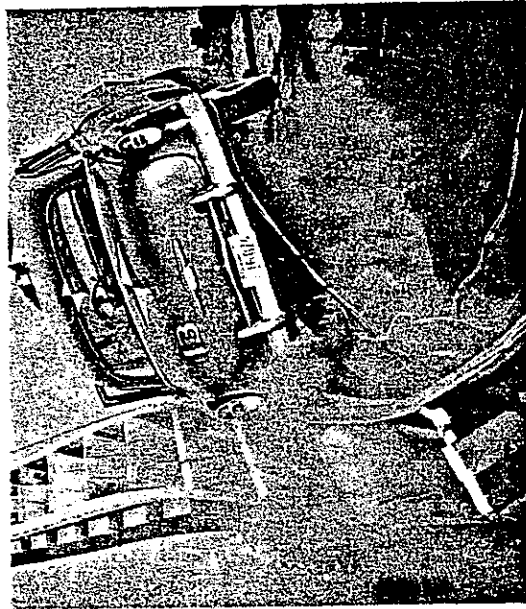
TEST NO. 12
 DATE 11-13-58
 VEHICLE Ford 52 Sedan
 SPEED 56 MPH
 IMPACT ANGLE 27 °
 VEHICLE WEIGHT ... 4002
 (W/DUMMY&INSTRUMENTATION)

DUMMY INJURY Possible neck injuries & minor bruises.
 GUARDRAIL DAMAGE 50' of Fence knocked out. No damage to Cable.
 POST DAMAGE 7 Posts damaged beyond repair.
 VEHICLE DAMAGE 6" Posts Bent.
 MAX. DYNAMIC DEFLECTION OF RAIL... 7'-2"
 VEHICLE DECELERATION (PEAK)..... Long. 69 G ... Transv. 154 G
 DUMMY DECELERATION (PEAK)..... Long 7 G ... Transv. 9.5 G

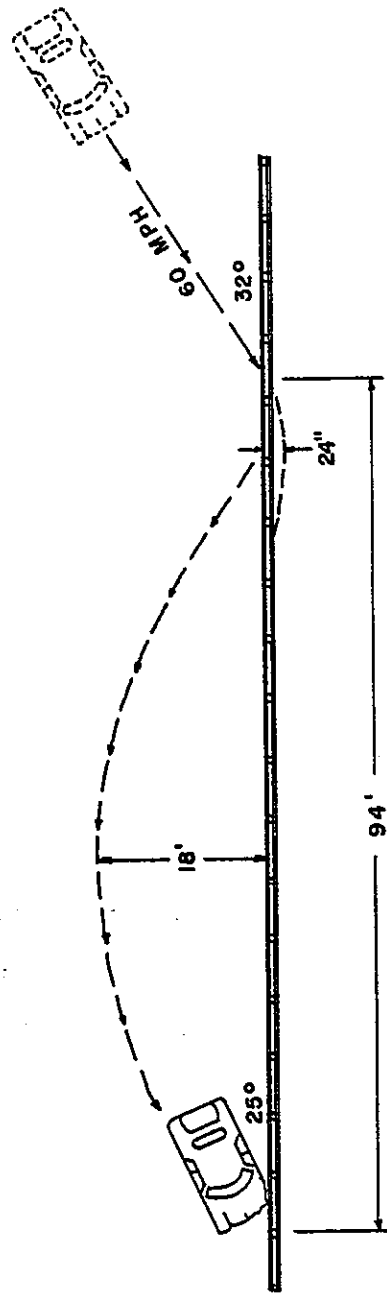
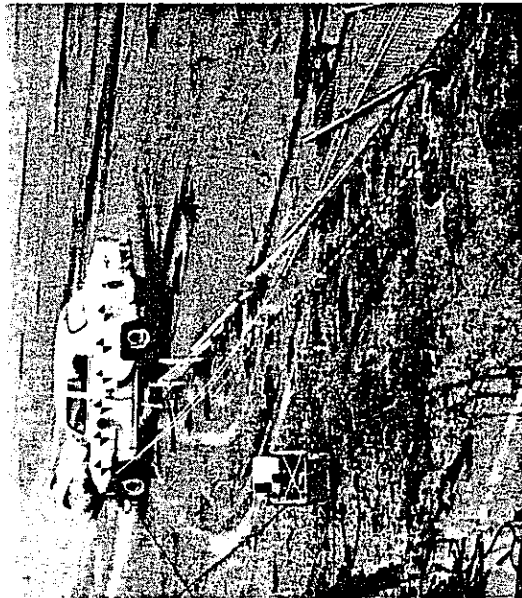
GUARDRAIL	W Section	DUMMY INJURY	Possible left shoulder, arm & side injuries.	TEST NO.	13
CHANNEL	6" x 8.2 #	GUARDRAIL DAMAGE	4 Sections damaged beyond repair.	DATE	12-18-58
BRACKET	8x8x12 D.F. Block	CHANNEL DAMAGE	4 Sections damaged beyond repair.	VEHICLE	Chev. 53 Sedan
POST	8x8 D.F.	POST DAMAGE	3 Posts damaged beyond repair.	SPEED	60 MPH
POST SPACING	6'-3" O.C.	VEHICLE DAMAGE	\$ 900	IMPACT ANGLE	32 °
LENGTH OF INSTALLATION	125'	MAX. DYNAMIC DEFLECTION OF RAIL	37"	VEHICLE WEIGHT	4000
GROUND CONDITION	Dry	VEHICLE DECELERATION (PEAK)	Long. 104 G ... Transv. 198 G	(W/DUMMY & INSTRUMENTATION)	
		DUMMY DECELERATION (PEAK)	Long. 16 G ... Transv. 18 G

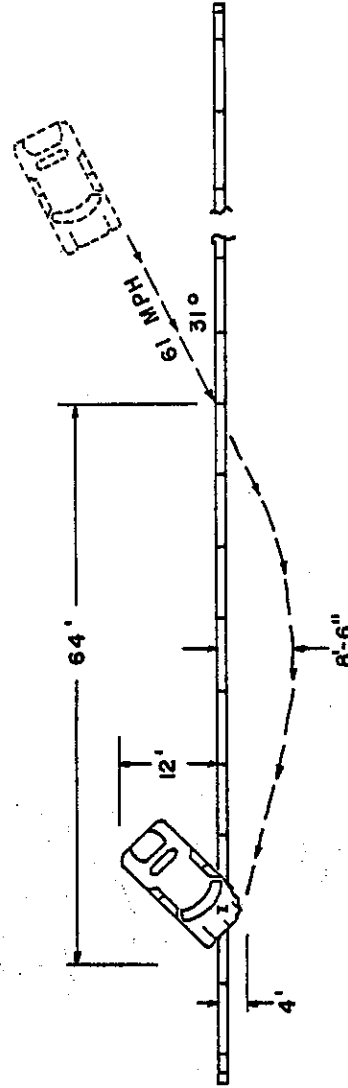
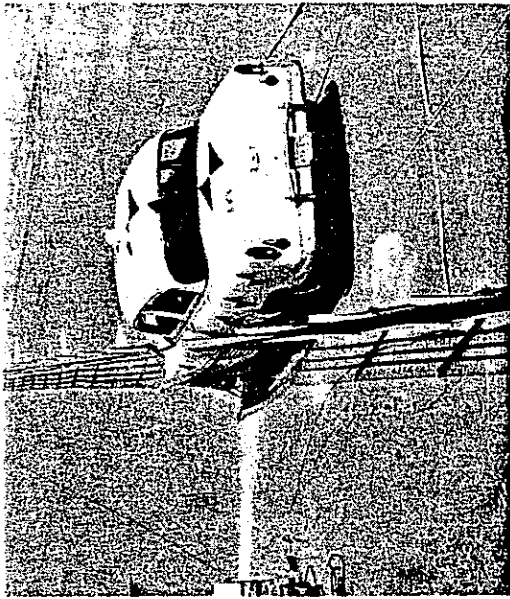
TEST NO. 14
DATE 12-26-58
VEHICLE Chev. 53 Sedan
SPEED 61 MPH
IMPACT ANGLE 31°
VEHICLE WEIGHT ... 4000
(W/DUMMY & INSTRUMENTATION)

DUMMY INJURY Minor Bruises & possible neck injuries.
GUARDRAIL DAMAGE 80' of Fence knocked out. No damage to Cables.

POST DAMAGE 11 Posts damaged beyond repair.

VEHICLE DAMAGE \$600.
MAX. DYNAMIC DEFLECTION OF RAIL ... 8'-6"

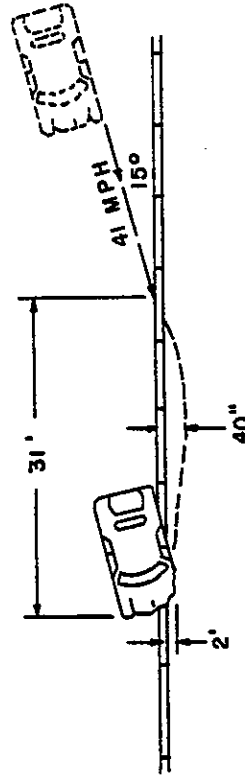
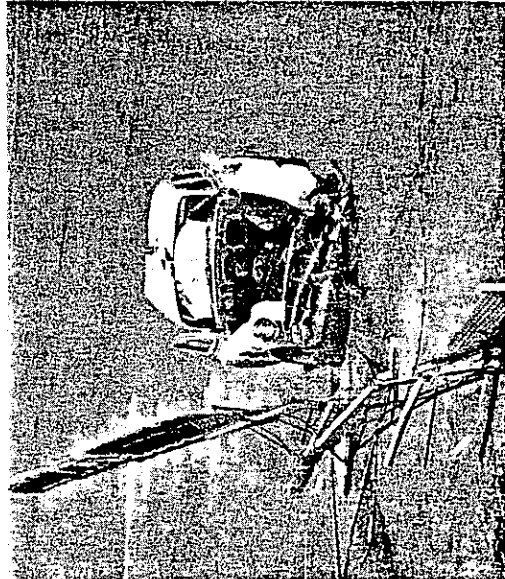
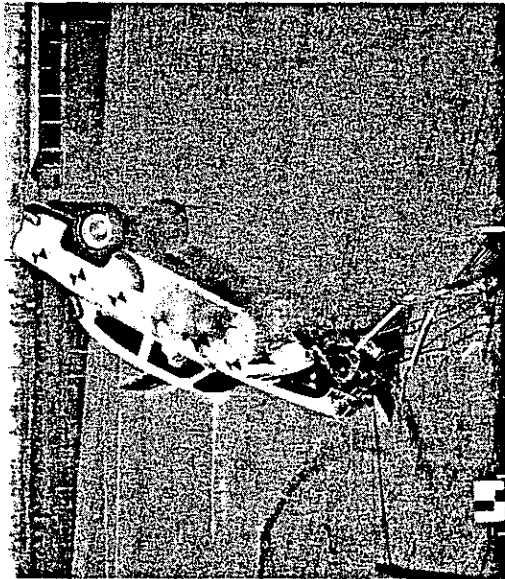
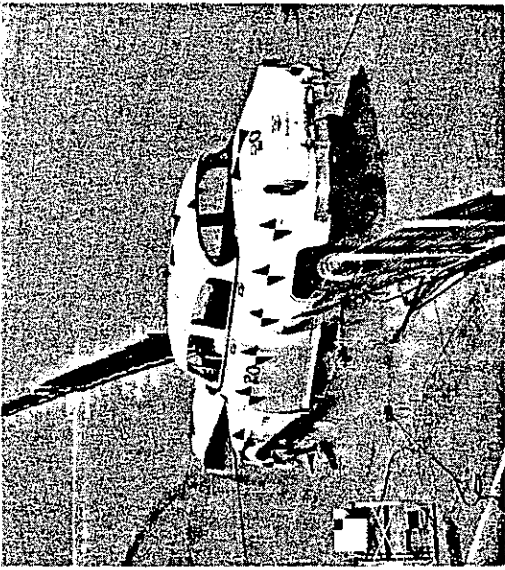
TEST NO 19
DATE 3-5-59
VEHICLE Chev. 53 Sedan
SPEED 41 MPH
IMPACT ANGLE 15°
VEHICLE WEIGHT 3700
(W/DUMMY & INSTRUMENTATION)

DUMMY INJURY Minor Bruises
GUARDRAIL DAMAGE 35' of Fence knocked out. No damage to cables.
POST DAMAGE 4 Posts damaged beyond repair.
VEHICLE DAMAGE \$ 400.
MAX. DYNAMIC DEFLECTION OF RAIL 40"
VEHICLE DECELERATION (PEAK) ... Long. 55 G ... Transv. 22 G
DUMMY DECELERATION (PEAK) Long. 3 G ... Transv. 2 G

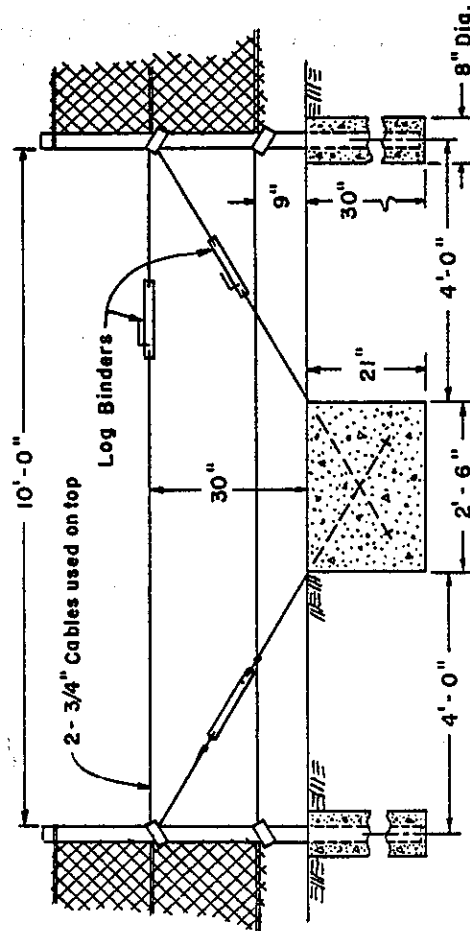
GUARDRAIL DAMAGE 24' of Fence knocked out.
 10' of Cable damaged.

POST DAMAGE 4 Posts damaged beyond repair.
 2 Posts Bent.

VEHICLE DAMAGE Total Loss

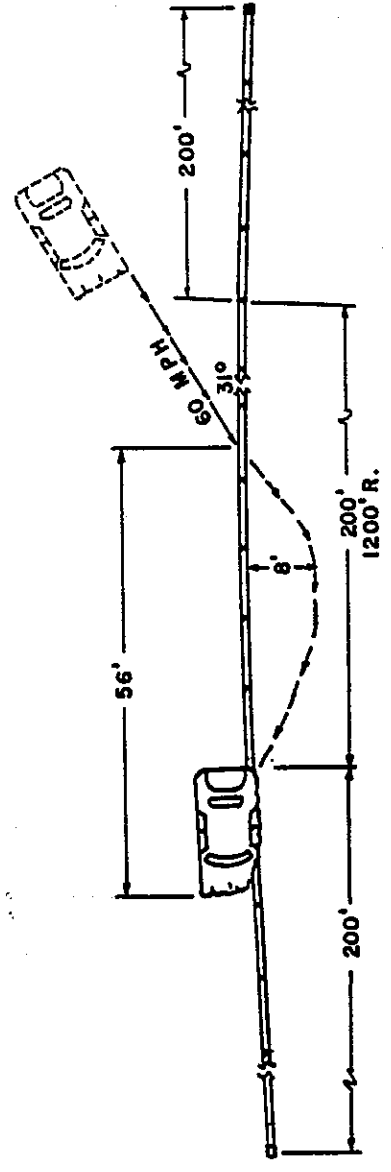
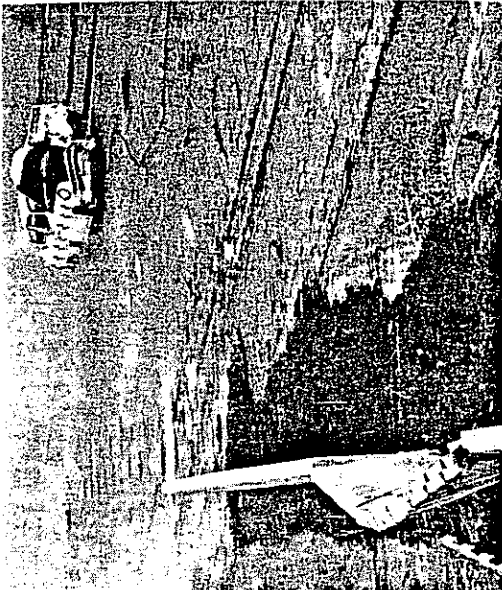
TEST NO. 21	DUMMY INJURY	Scalp laceration , possible chest injuries.
DATE 3-20-59	GUARDRAIL DAMAGE	56' of fence knocked out. No damage to cables.
VEHICLE Chev. 53 Sedan	POST DAMAGE	12 posts damaged beyond repair.
SPEED 60 MPH	VEHICLE DAMAGE	Total loss.
IMPACT ANGLE ... 31°	MAX. DYNAMIC DEFLECTION OF RAIL ...	8'
VEHICLE WEIGHT ... 3850	VEHICLE DECELERATION (PEAK) ...	Long. NG ...Transv. NG
(W/ DUMMY & INSTRUMENTATION)	DUMMY DECELERATION (PEAK)	Long. 66 ...Transv. 46

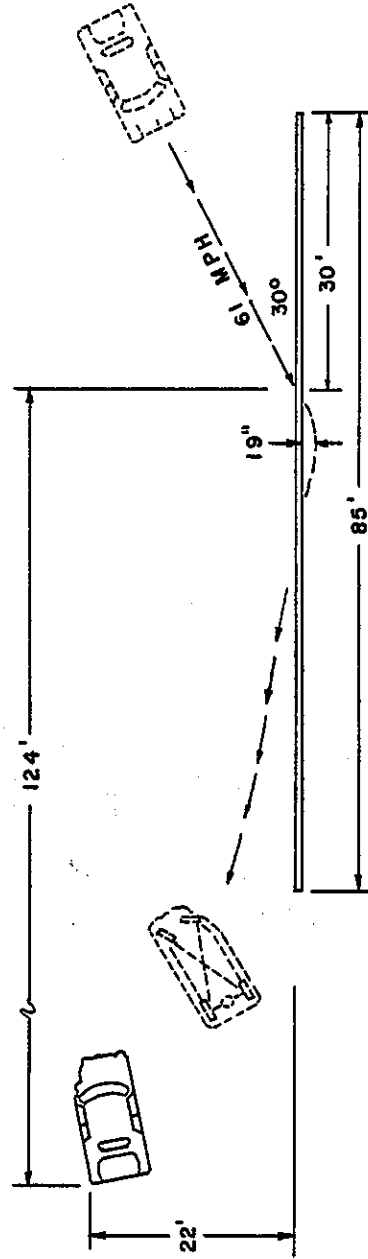
TEST NO. 22
 DATE 3-30-59
 VEHICLE Chev. 53 Sedan
 SPEED 61 MPH
 IMPACT ANGLE ... 30°
 VEHICLE WEIGHT ... 3850
 (W/DUMMY & INSTRUMENTATION)

Indications from the results of Test No. 22 (Exhibit 19) are that the design of this rail needs only a slight amount of stiffening to make it serve under heavy collisions. Previous tests on bridge rails indicate that a wall as low as 27" in height could be effective as long as it did not fail. The reflective action from a properly designed concrete wall as indicated by previous tests conducted on bridge rails shows that the offending vehicle will reflect from the concrete wall with an abrupt change in direction and with high decelerations caused by the extremely rapid reflection of the vehicle from the non-deflecting surface. There is good opportunity, however, for evasive action by following cars in that the reflection angle is normally flat and due to the damaged colliding wheel the car tends to curve back into the rail and come to rest against it. There is even less opportunity of evading stalled traffic ahead after collision than there is with the semi-rigid type of barrier.

The failure of the light concrete wall used in Test No. 22 served to illustrate again the fact that when a rail "lays over" during a heavy collision, no matter what the height, a high speed colliding vehicle will tend to roll after reflecting from the barrier. Thus it is evident that any barrier design in which it is expected that measurable downward deflection will take place, then provision must be made to hold the restraining unit (rail, cable, etc.) at or above the center of gravity of the vehicle at the first instant of and throughout collision.

DUMMY INJURY Concussion, severe shoulder & chest injuries.
 GUARDRAIL DAMAGE 20' Wall broken
 VEHICLE DAMAGE Total loss
 MAX. DYNAMIC DEFLECTION OF RAIL... 22"
 VEHICLE DECELERATION (PEAK) Long. 112G... Transv. 72G
 DUMMY DECELERATION (PEAK) Long. 21G... Transv. 25G

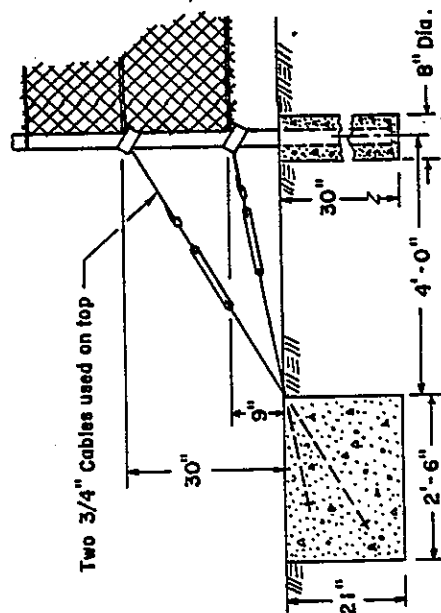
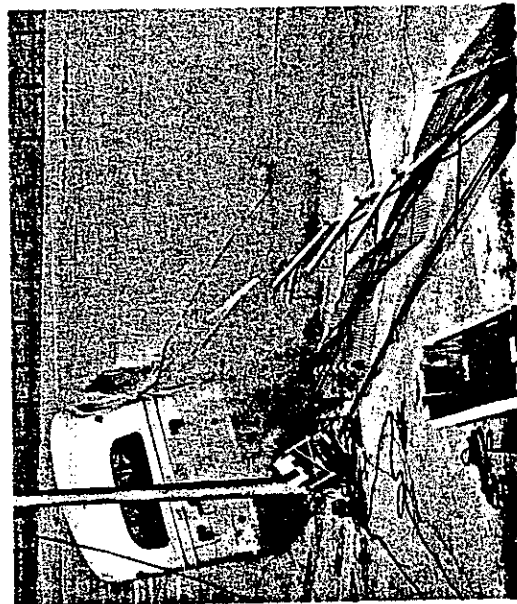
DUMMY INJURY Left shoulder injuries.
GUARDRAIL DAMAGE 90' of fence knocked out. No damage to cables.
POST DAMAGE 23 Posts damaged beyond repair.
VEHICLE DAMAGE \$ 1200
MAX. DYNAMIC DEFLECTION OF RAIL... 12'
DUMMY DECELERATION (PEAK) Long. 2.8G... Transv. 9.3G

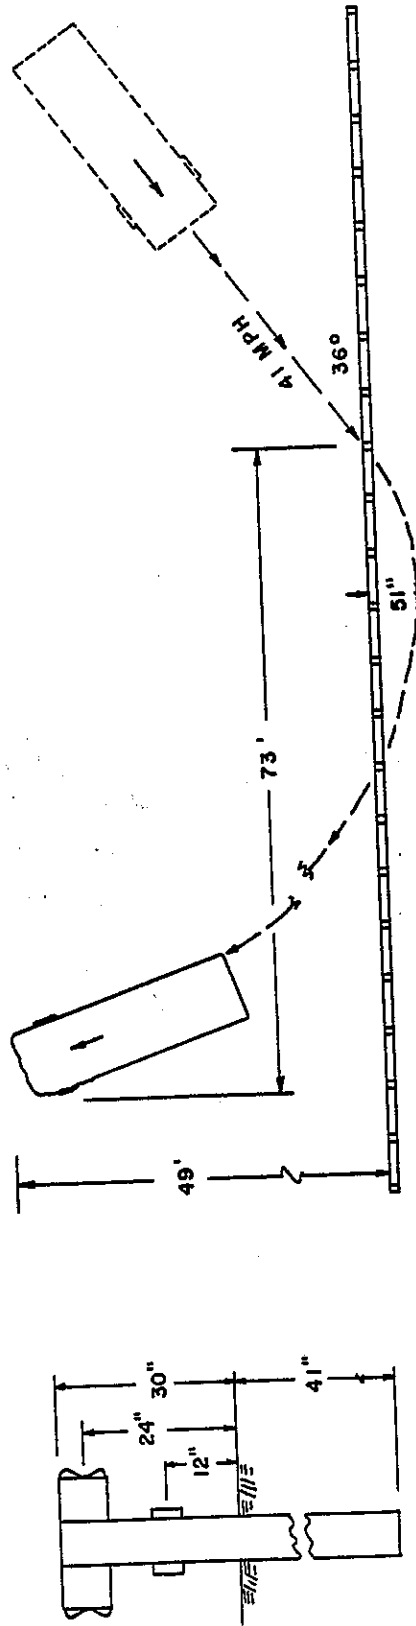
GUARDRAIL	W Section	DUMMY INJURY	Critical head, neck & shoulder injuries; severe body bruises.	TEST NO.	24
CHANNEL	6" 17 8.2 #	GUARDRAIL DAMAGE	7 Sections damaged beyond repair.	DATE	4-30-59
BRACKET	8x8x12 D.F. Block	CHANNEL DAMAGE	4 Damaged beyond repair.	VEHICLE	1937-40 pass. Bus.
POST	8 x 8 D.F.	POST DAMAGE	5 Damaged beyond repair.	SPEED	41 MPH
POST SPACING	6'-3" O.C.	VEHICLE DAMAGE	\$ 1,500	IMPACT ANGLE	36°
LENGTH OF INSTALLATION	125'	MAX. DYNAMIC DEFLECTION OF RAIL	58"	VEHICLE WEIGHT	17,500
GROUND CONDITION	Dry	DUMMY DECELERATION (PEAK)	Long. 6G ... Transv. 25 G	(W/DUMMY & INSTRUMENTATION)
